FITTING INSTRUCTIONS:

INSTALLING YOUR NEW EXEDY CLUTCH

Technical-Insert 3 • 08/07/2020

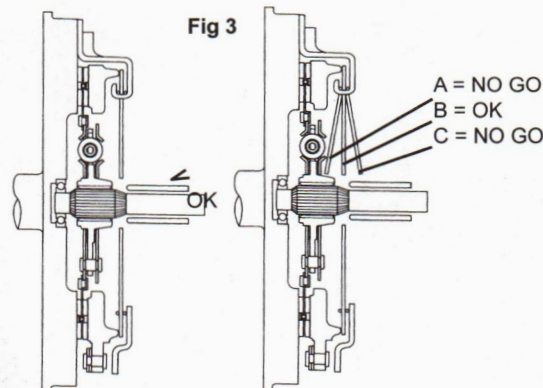
3. For installation instructions please refer to the factory service manual.
4. **Flywheel must be replaced or machined as shown below (Fig 2 max 0.03 in.) or warranty will be void** and check pilot bearing or the pilot bushing and replace if necessary. Please note pilot bushing noises are more apparent when the engine and transmission systems are cold (i.e. in the mornings). Dual mass flywheels and flex type flywheels must be replaced with the clutch kit.

8. When the pressure plate has been torqued down securely to the flywheel, ensure that the diaphragm tips (in the case of a lever type cover assembly, the release lever tips) are in a parallel or slightly upward position (see Fig 3) and do not go over center of the parallel position.

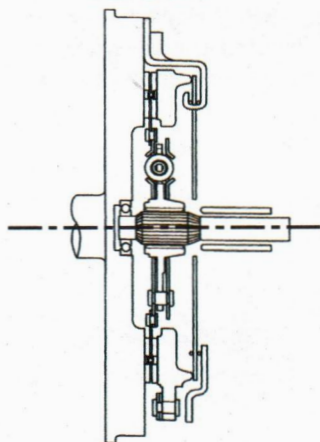
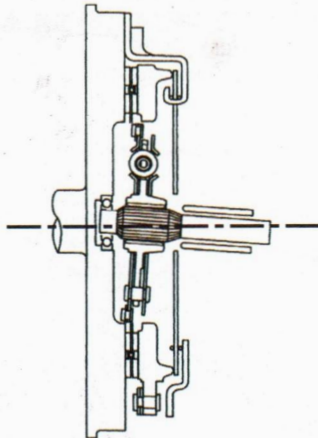
Hanging the Gearbox

9. Refit gear box, taking care not to bend the clutch disc. Never hang the gear box off the clutch disc or use any force to align gear box shaft.
10. Check all bell housing dowels are in correct position and tighten bell housing bolts. Ensure there is no dirt or foreign material between the mating surfaces of the engine and the bell housing.

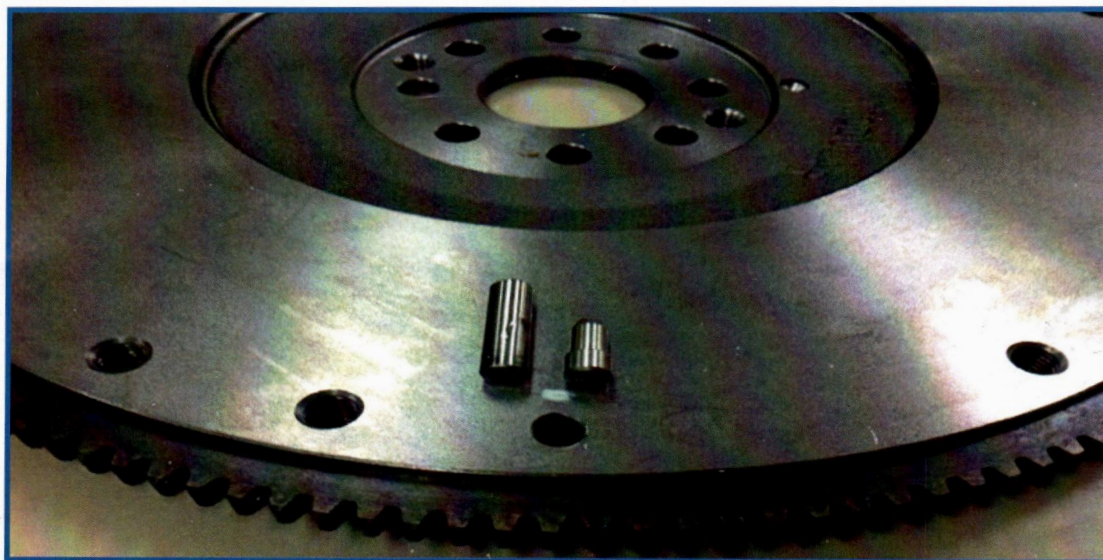
You MUST change the dowel pins on the 2011-up Ford Mustang 5.0L when using the OEM flywheel with the EXEDY clutch kit. New dowel pins are supplied with the clutch kit.

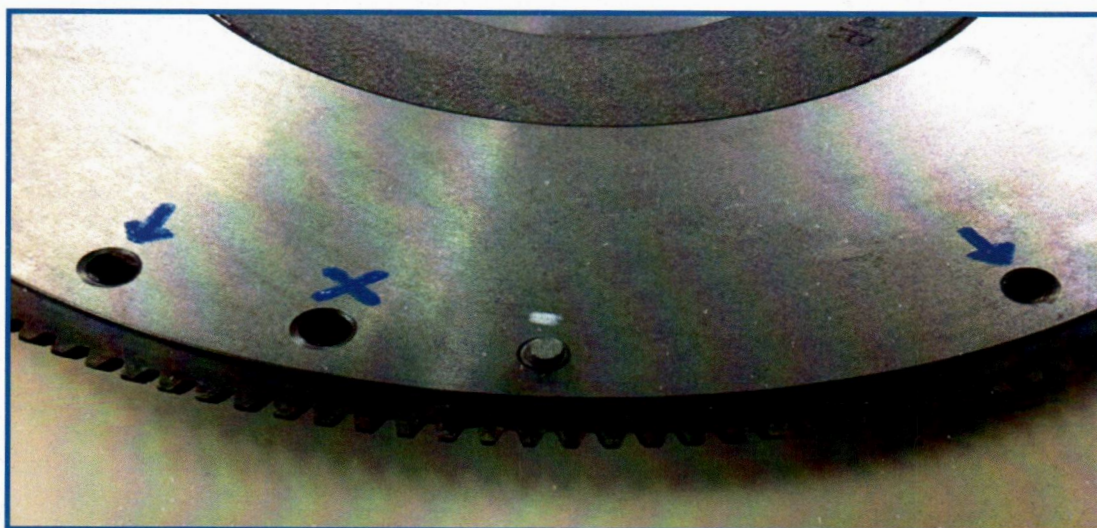
When using the EXEDY clutch kit with the OEM flywheel you will only use the most outer 2 bolts to mount the pressure plate. We also recommend the use of Loctite on the bolts.
