DECKLID PANEL

(2015-2017 MUSTANG ALL)

INSTALLATION INSTRUCTIONS

SKU # 408126

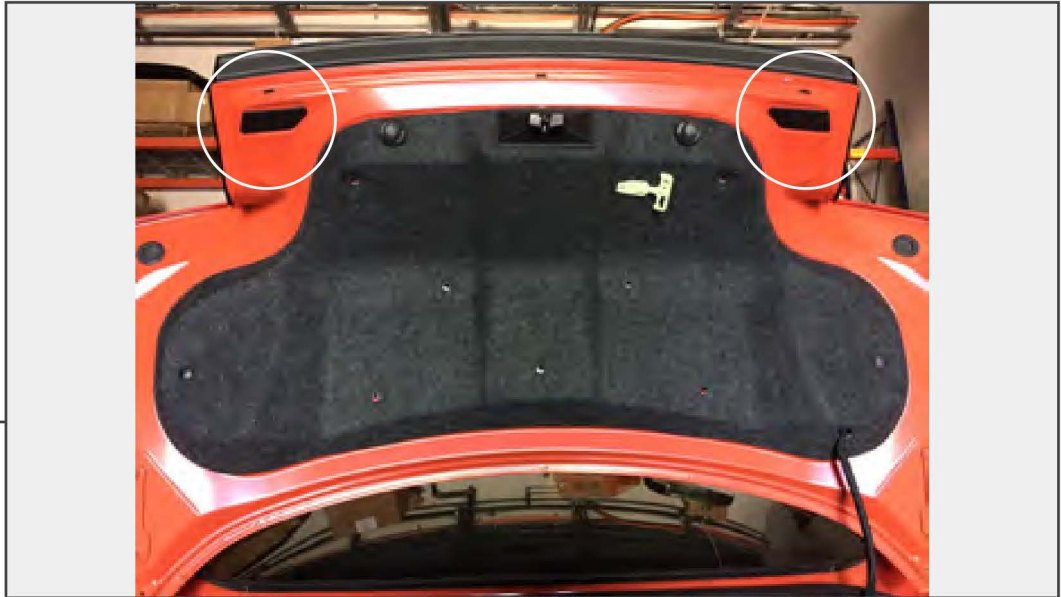
STEP 1

Using the Trim Panel Removal Tool, gently remove the caps covering the decklid panel bolts. Remove the (4) 7mm bolts, taking your time so they don't accidentally fall between inner and outer layers of the panel.

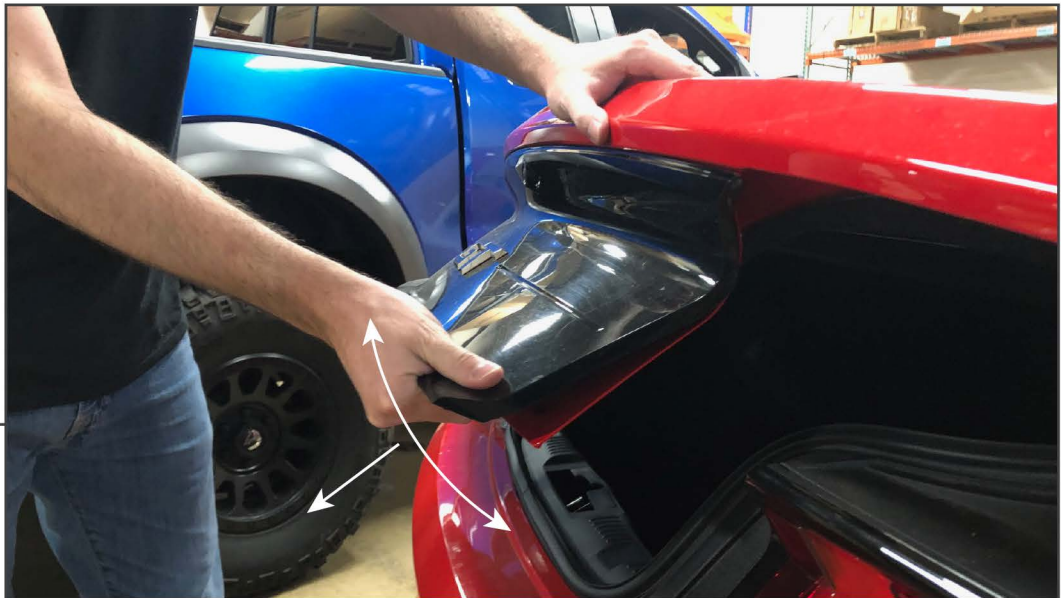
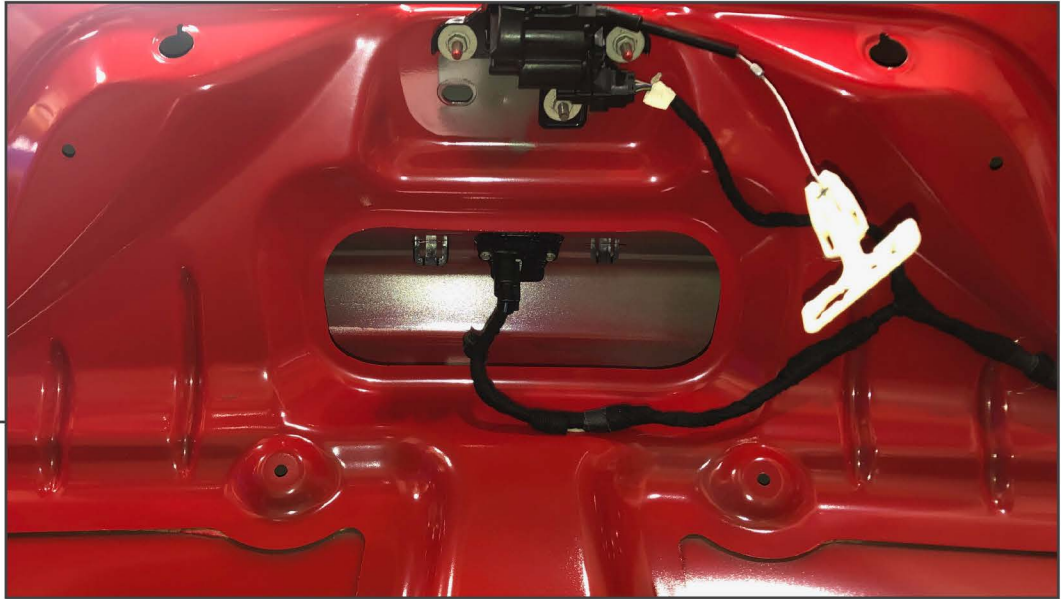
STEP 2

To release the top clips of the decklid panel, start on the left or right hand side and grab the bottom edge of the panel, which should be loose since you've removed the (4) 7mm bolts. Gently rotate the panel up and down while pulling light towards you, gradually increase pulling force as necessary. This process will release the (4) metal clips at the top of the decklid panel, but there are still (2) plastic clips directly next to the reverse camera that will need to be release by removing the trunk lid liner in the next step. **AGGRESSIVE PULLING CAN CAUSE THE SHEET METAL AROUND THE CLIP LOCATIONS TO BEND, SO PLEASE TAKE YOUR TIME.**

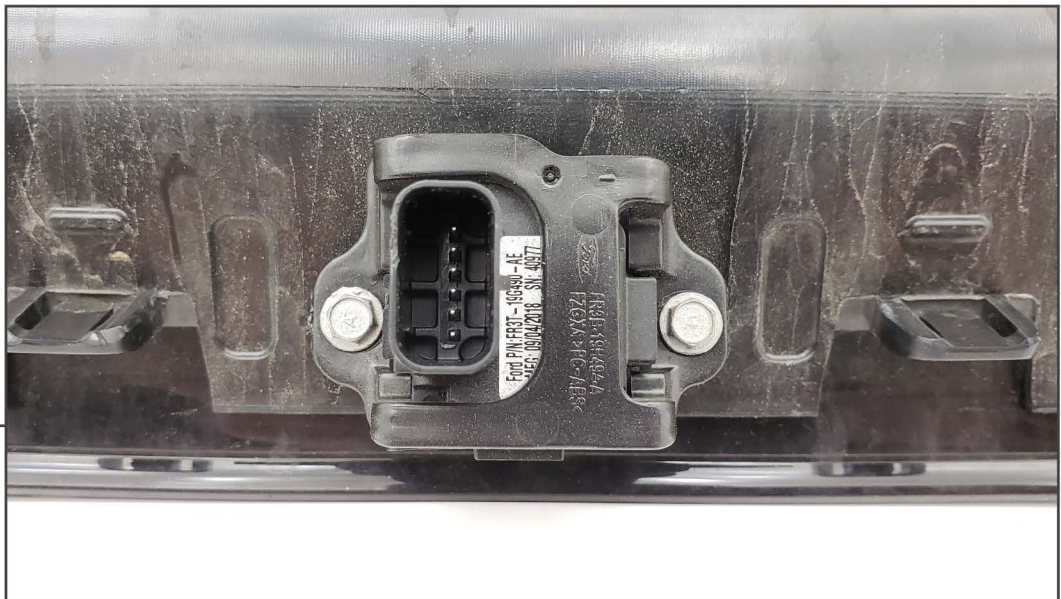
**STEP 3**

Remove the (9) push rivets, (2) rubber bumpers, and trunk latch trim to remove the trunk lid liner. Once the liner is removed you will have access to the (2) remaining clips holding the decklid panel and the reverse camera wiring harness. Release the clips, unplug the harness, and remove the decklid panel from the vehicle.

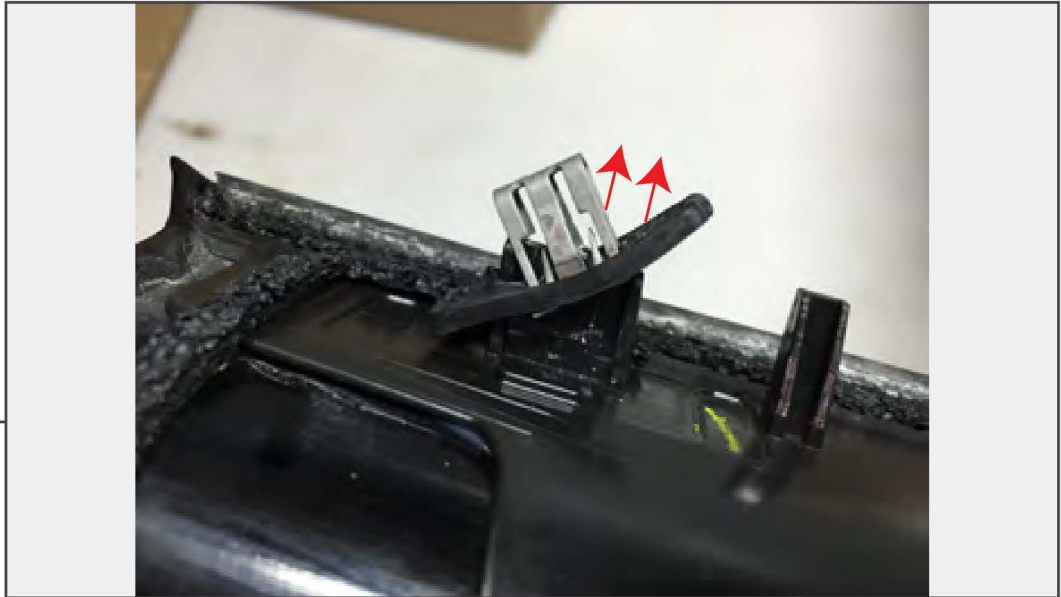
**STEP 4**

Remove the (2) 5.5mm bolts on either side of the reverse camera and reinstall the assembly onto the Saleen decklid panel, reusing the factory bolts. Make sure you keep the same camera orientation or the image will be upside down.

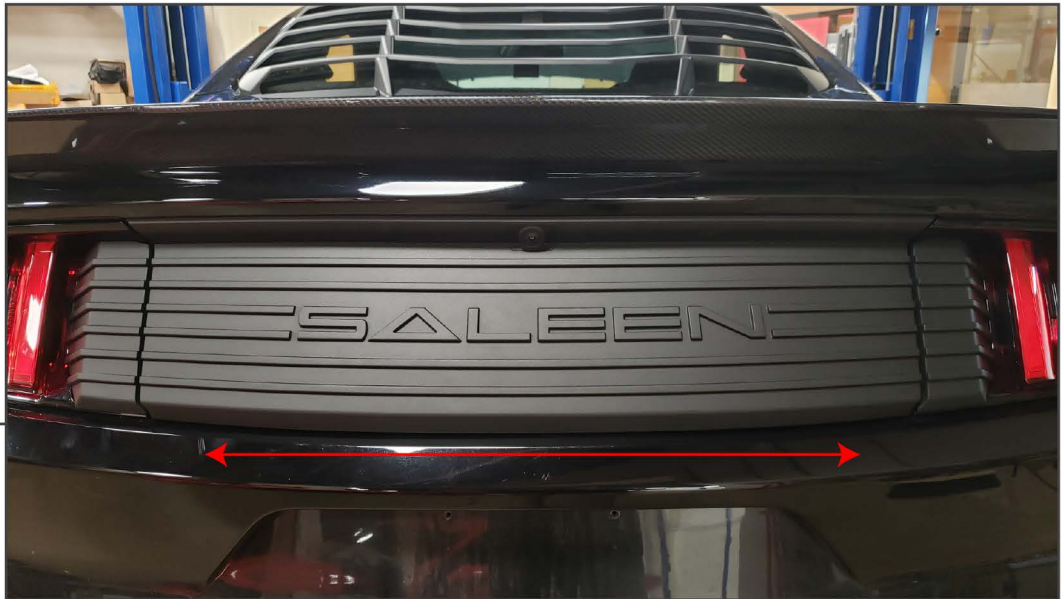
STEP 8

Dry fit the taillight to get a clear idea of how the cover should fit on the tail light. Next, align and install the cover, pressing firmly to seat the adhesive. Repeat this step for the opposite side to complete the installation. **TRUNK/TAIL LIGHT ALIGNMENT CAN VARY BETWEEN VEHICLES. IF THERE ARE ALIGNMENT ISSUES BETWEEN THE TAIL LIGHT COVER AND THE DECKLID PANEL, PLEASE REFER TO THE TROUBLESHOOT SECTION.**

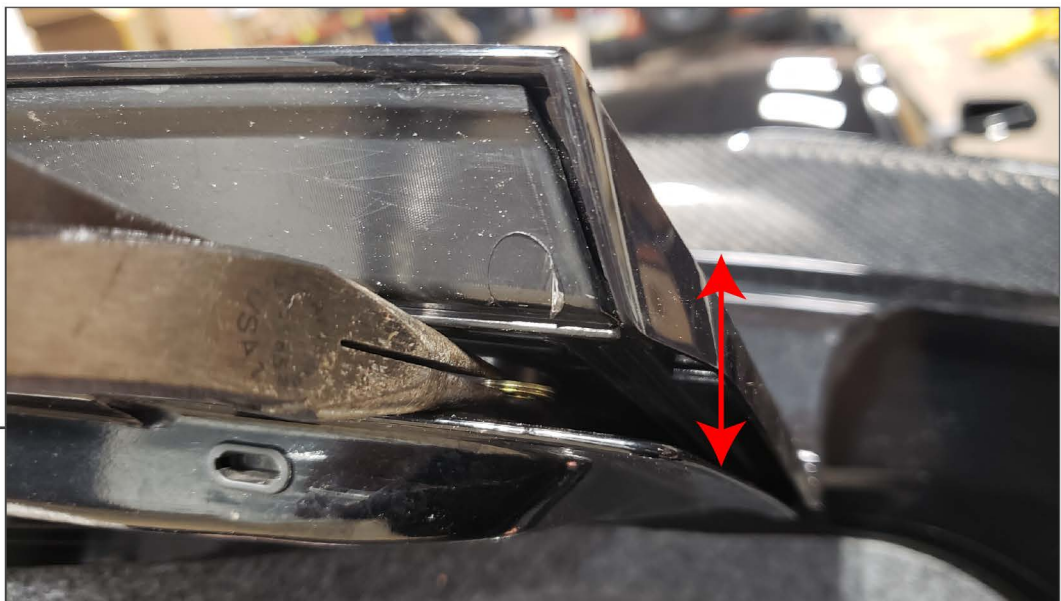
TROUBLESHOOTING

If the gap between the decklid and both tail light covers is not the same, loosen the (4) 7mm screws on the bottom of the decklid panel and shift the panel as needed.

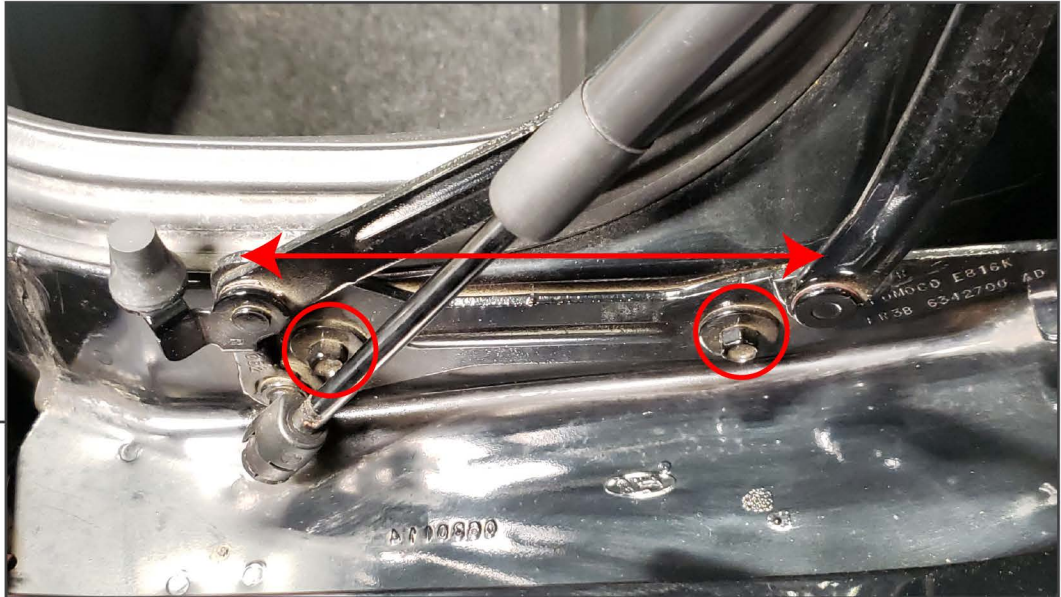
TROUBLESHOOTING

If the tail light covers are sticking out further than the decklid panel, remove the screws and use the supplied washers as spacers to adjust the panel outward as needed.
